# ***INSPECTION BULLETIN***

## ***Tank Car Inboard Stub Sill***

### ***Inspection and Modification***

**Application Criteria:** ARI Tank Cars built prior to Oct 1, 2011 with ARI 300 stub sills.

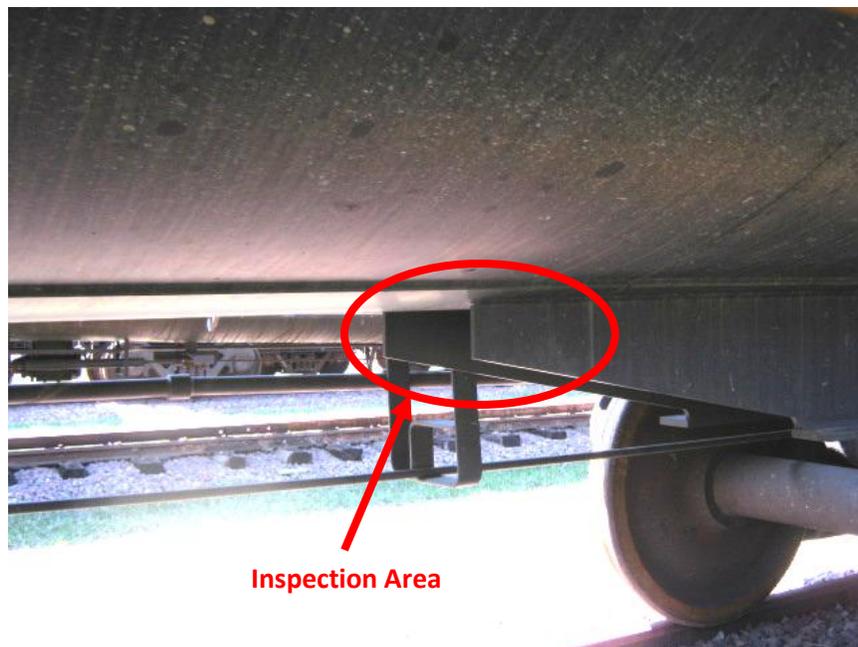
**Figure 1**

Inspect the cradle pad for any cracks at the inboard termination of the draft sill, this area is shown in Figure 1. Visual inspection can be aided with non-destructive testing as deemed necessary by the inspector. The type of modification to be performed is to be determined by the results of the inspection:

Condition 1: No cracks found in cradle pad. (Modification 1)

Condition 2: Cracks of any length found in cradle pad. (Modification 2)
